Manhole Inspection Summary

Manhole # S31GG_061MH

Insp Date: **8/25/08 1:16 PM**

Location Address: **250 LANVALE ST**

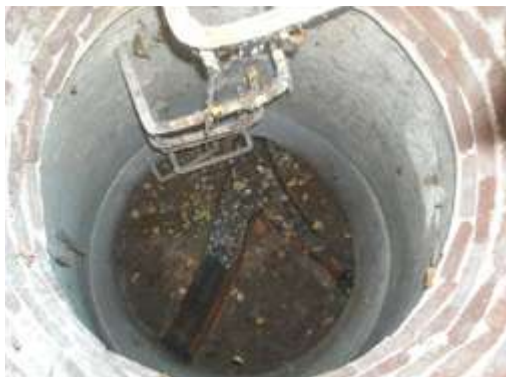
Top View

☒ **Evidence Of Surcharge**

Depth: **1.5** (ft.) ☐ Active Surcharge Present

Evidence of surcharge - Bench debris.
Channel debris.

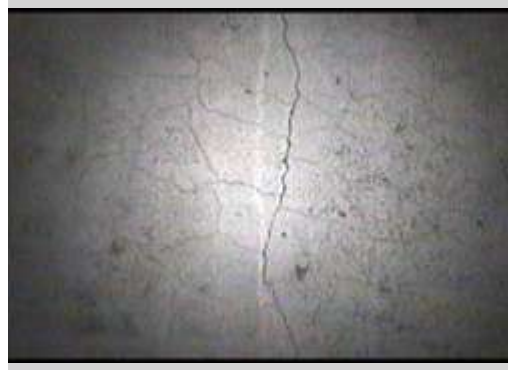
Defect

Condition: ☐ Sound ☒ **Cracked** ☐ Root Intrusion ☐ Loose Brick ☐ Deteriorated

Infiltration: ☐ None ☒ **Joint** ☒ **Cracks** ☐ Mortar ☐ Roots ☐ Wall

Corbel cracks and infiltration.

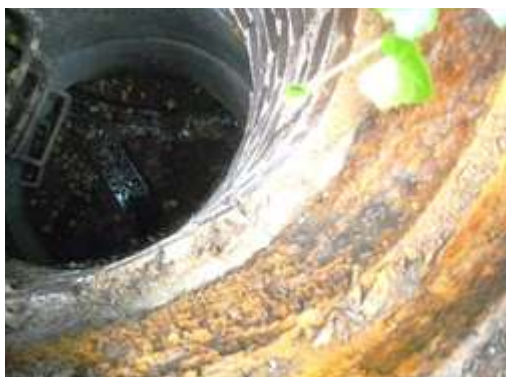
Defect

Condition: ☐ Sound ☐ Cracked ☐ Root Intrusion ☐ Loose Brick ☒ **Deteriorated**

Infiltration: ☐ None ☒ **Joint** ☐ Cracks ☒ **Mortar** ☐ Roots ☐ Wall

Adjustment deterioration and infiltration.

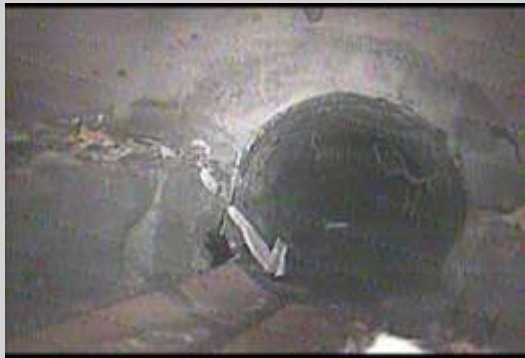
8 in. Circular Gravity Sewer Pipe Out @ 12 O'Clock

Infiltration: **Evidence** Pipe Seal Cond: **Unknown**

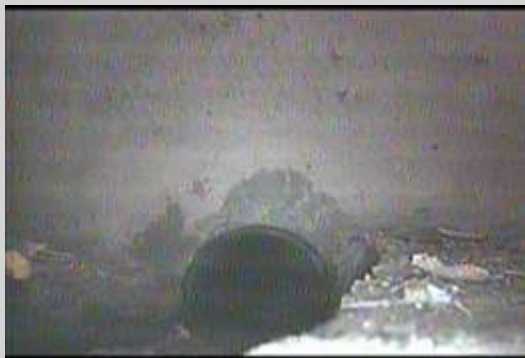
6 in. Circular Gravity Sewer Pipe In @ 4 O'Clock

Infiltration: **Evidence** Pipe Seal Cond: **Unknown**

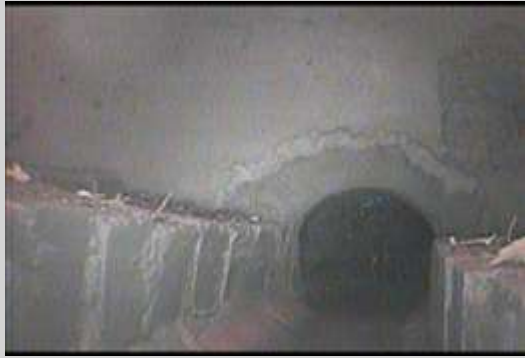
8 in. Circular Gravity Sewer

Infiltration: **Evidence**
